## Case Studies of Central Office Cable Tray Support Failures

Dan McMenamin  
Specialist - Energy & Environment

Bell Atlantic Corporation  
1717 Arch Street Suite 1700  
Philadelphia, Pennsylvania 19103 USA  
215-466-2125

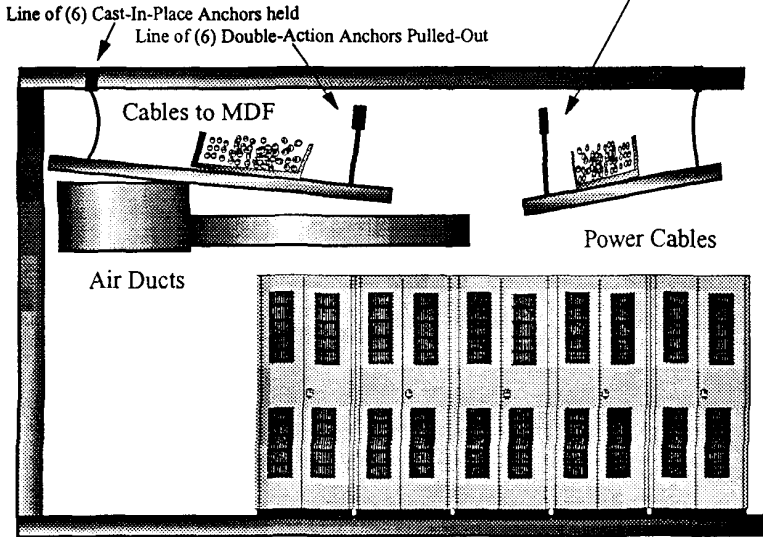
Wayne, PA

The anchors which pulled out are double action expansion shield types (see sketches and photo of threaded rod and anchor). The anchors were installed by a buildings construction contractor approximately three years ago. Investigation of the incident revealed that the concrete was quite strong; its' compressive strength measured more than 7,000 PSI with a rebound hammer. The anchor installation, however, was flawed in several ways.

The anchor requires a hole one-inch (2.54 CM) in diameter by three-inches (7.62 CM) deep. The first hole drilled by the contractor struck a reinforcing rod (called REBAR in the trades) embedded approximately 5/8-inch (1.6 CM) into the concrete. The proper procedure, at this point, is to move over approximately two inches (5 CM) and drill again. The mechanic drilled the second hole approximately 3/4-inch (1.9 CM). The result was a deformed hole as shown in the sketch marked "Failure Sequence."

(4) Double-Action Anchors Pulled-Out

At this point, the mechanic inserted the anchor and attempted to set it using a 5/8-13 hex-headed bolt and washer. The anchor wouldn't set, instead, it spun in the hole. The mechanic removed the anchor and wrapped it with duct tape in the mistaken belief that it would fill the gap between the anchor and the hole, thus allowing the anchor to set. Obviously, expanding the anchor slightly with the bolt would have been a better choice. Regardless, once the bolt was tight, the mechanic believed it "set" and removed the bolt. Some twenty-four anchors were improperly installed this way.

A telephone equipment installer screwed-in threaded rods and tightened them with flat-washers and 5/8-13 nuts. Because of the hole deformity and the duct tape drastically reduced the shield-to-concrete friction needed to secure the anchor, the framework and cable rack assembly pulled the anchors out of the ceiling beginning at the heaviest end, and progressing towards the lighter end.

Temporary repairs employed stanchions and jacks to support the mass of framing and cabling. Because of the hole deformity, anchors could not be set in the existing holes. Since digital switching systems are sensitive to dust, prudence dictated the repair be accomplished without drilling directly above the switch. A length of angle iron was fastened to the wall to support one end of the framing (see repair sketch). The other end was supported using the switching equipment frames for support, with standoff insulators used to maintain the integrity of the isolated ground plane.

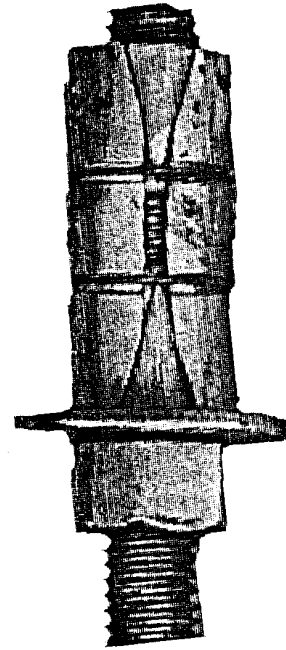
Photo - pulled-out anchor from Wayne (tape removed)

Conclusion: Expansion shield had insufficient friction with concrete because the hole was deformed and the duct tape acted like a lubricant.

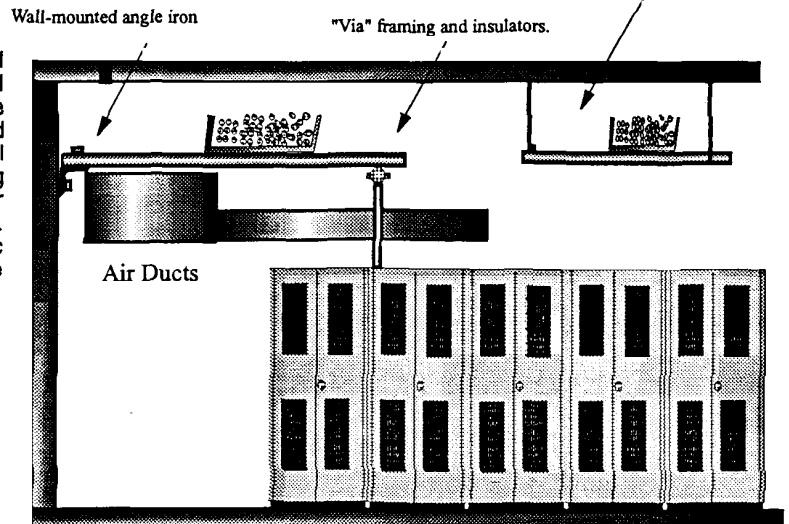
Wayne Repairs

Power rack resupported using nearby framing.

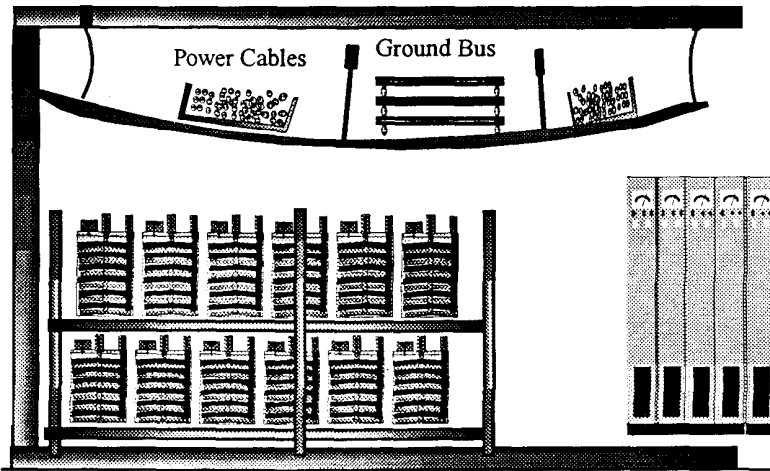
Bethlehem, PA

(~14) Single-Action Anchors Pulled-Out

A partial cable rack collapse occurred in a basement power room. The problem was discovered after a small earthquake measuring approximately 4.3 on the Richter scale shook Reading, a town some 40 miles to the West. Close examination of photographs taken more than a year ago, however, show some anchors beginning to slip. Accordingly, the earthquake is not considered a causal event. As may be seen in the sketches and photos, a partial pull-out of the ceiling anchors occurred, allowing the framing to bow in the center.

The combined weight of the cables, racks and framing in the area is estimated at 1,600 pounds (727 Kg), with an average of 270 pounds (122 Kg) supported by each anchor. Remarkably, some of the pulled-out anchors were carrying less than fifty pounds (23 Kg). The anchors were single-action expansion shields 2-1/2 inches long, rated at 1,500 pounds (680 Kg) safe-working load specified by the manufacturer.

Investigation revealed that the concrete averaged more than 6,000 PSI, compressive strength as measured with a rebound hammer. The holes were clean and not excessively "powdery." The anchors felt snug in the holes, even when they were "unset" with a hammer blow to the loosened threaded rods, indicating that the holes were correctly sized. Some of the nuts seemed a bit loose in the field, and our initial reaction was that this contributed to the failure. Tests performed in the laboratory, as noted herein, show that even light loads cause sufficient "creep" in the expansion shield for tight nuts and washers to actually lose contact with the ceiling.

As such, this is an unexplained failure, thought (probably) to be anchors poorly set at installation time, some thirty years ago. Because the power equipment is less dust sensitive, new holes were drilled and drop-in type anchors added.
