Mitigating Construction & Demolition Vibration Damage on Stationary Batteries and Electronic Systems - What to do when someone rocks your world

Dan McMenemy – President - Dan McMenemy and Associates, Inc.

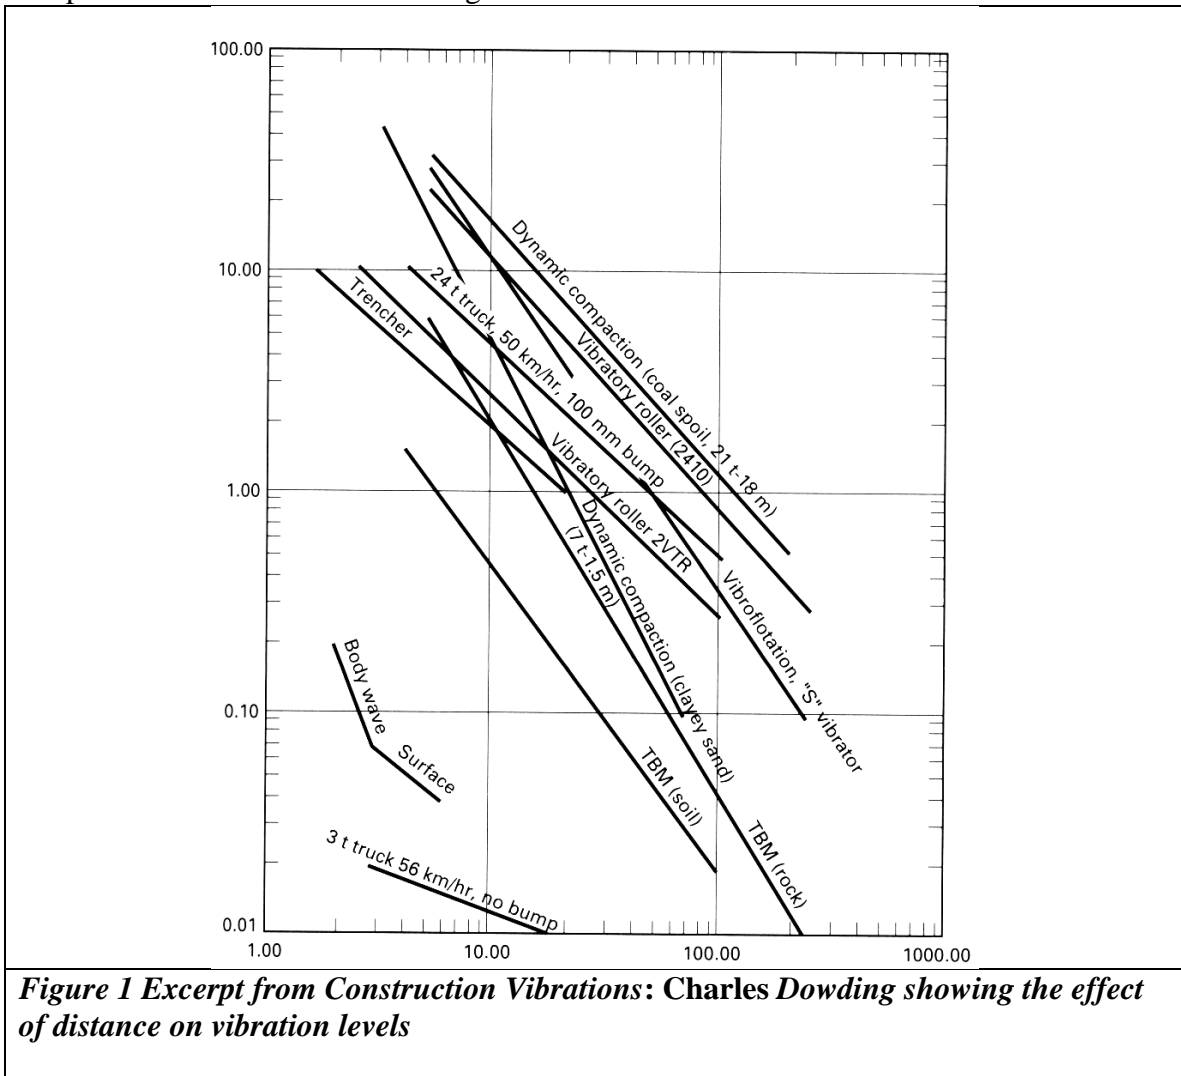
Figure 1 Excerpt from Construction Vibrations: Charles Dowding showing the effect of distance on vibration levels

Generally speaking the lower the frequency of the mechanical energy the more likely it is to propagate through soil, rock and building structures where it may cause equipment problems. Further, the softer the soil the more likely it is to conduct vibration energy with peat or swampy soil or poor grade alluvium being about the most active of the conductors and having the potential for the most circuit equipment damage. Further, since building height tends to amplify vibration fairly linearly, equipment on upper floors may be exposed to more vibration than equipment on or near the ground floor.

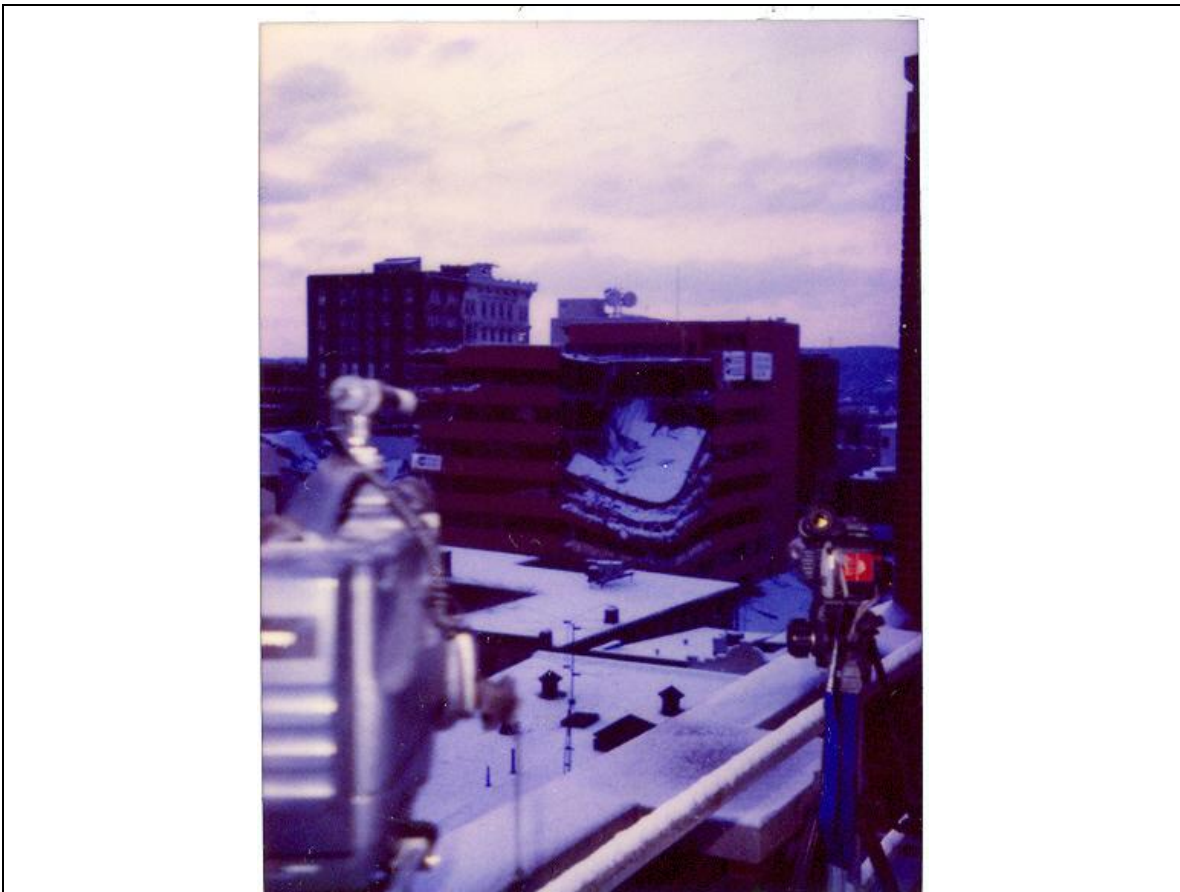
Fig 6 This photo is taken from the snow covered roof of a telephone central office in Allentown Pennsylvania where a pair of video cameras will record the implosion of a damaged 8 year-old office building. A sinkhole caused the structural failure of one corner of the building as can be seen by the partial collapse.

As may be seen in Figure 6, an office building about a city block from a multistory telecommunications central office building was in need of demolition after a sinkhole caused the structural failure of one corner of the building. Due to the proximity of nearby structures the means chosen for demolition was a “pancake” type of implosion technique. Because the telephone building is 367 feet from the nearest edge implosion site there was no sufficient risk of vibration damage from the explosive blast or the impact of the building remains pummeling the ground.
