Maintaining An Effectively Bonded and Grounded Network in an Age of Copper Theft

Keeping the bad guys from copping your copper

**Dan McMenamin
President**

**Dan McMenamin and Associates, Inc.
West Deptford, NJ 08051-1712 (USA)**

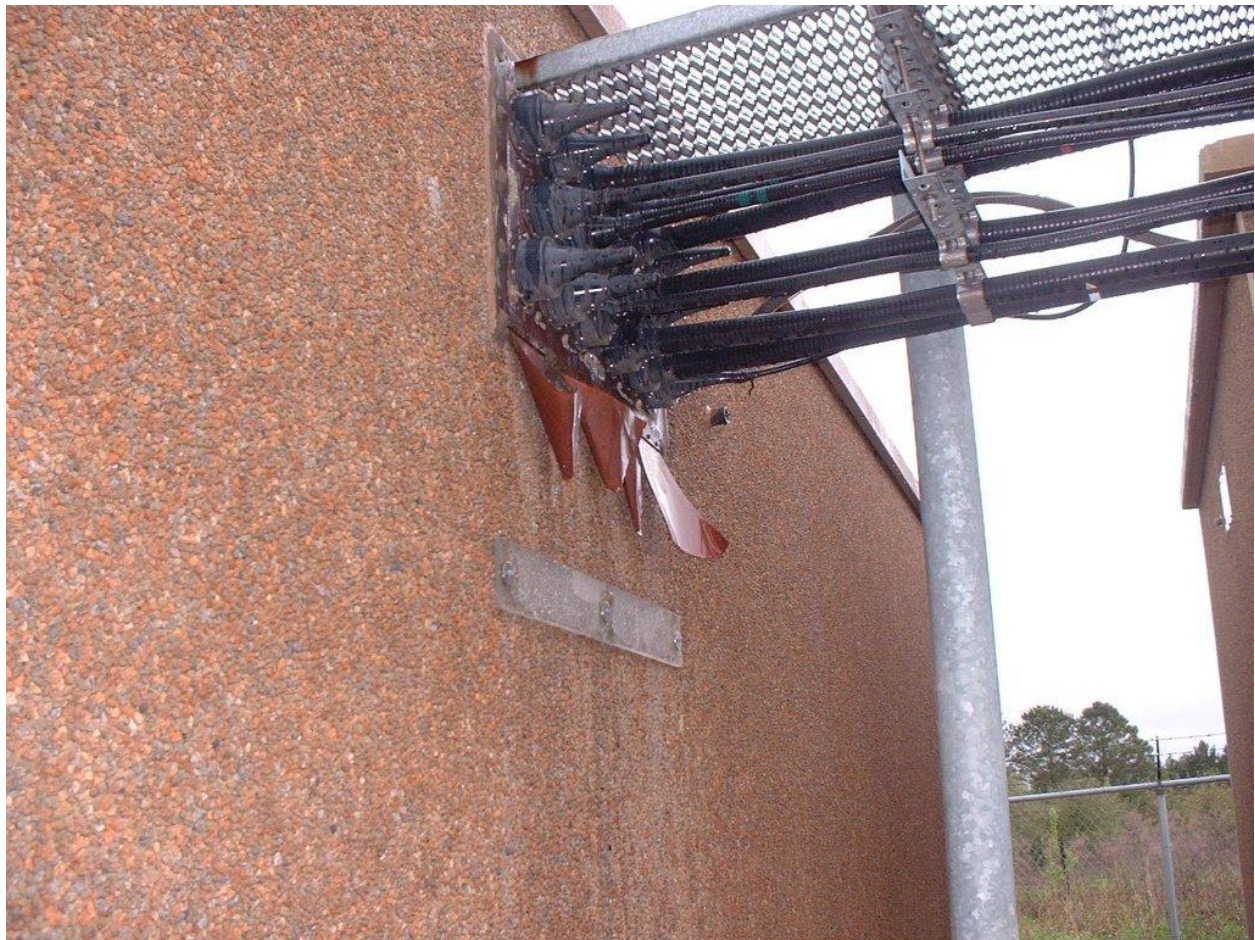
Figure 1 depicts four cut copper ribbons that once connected the hatch plate and the ground bar just inside the hatch plate to the buried Ground ring.

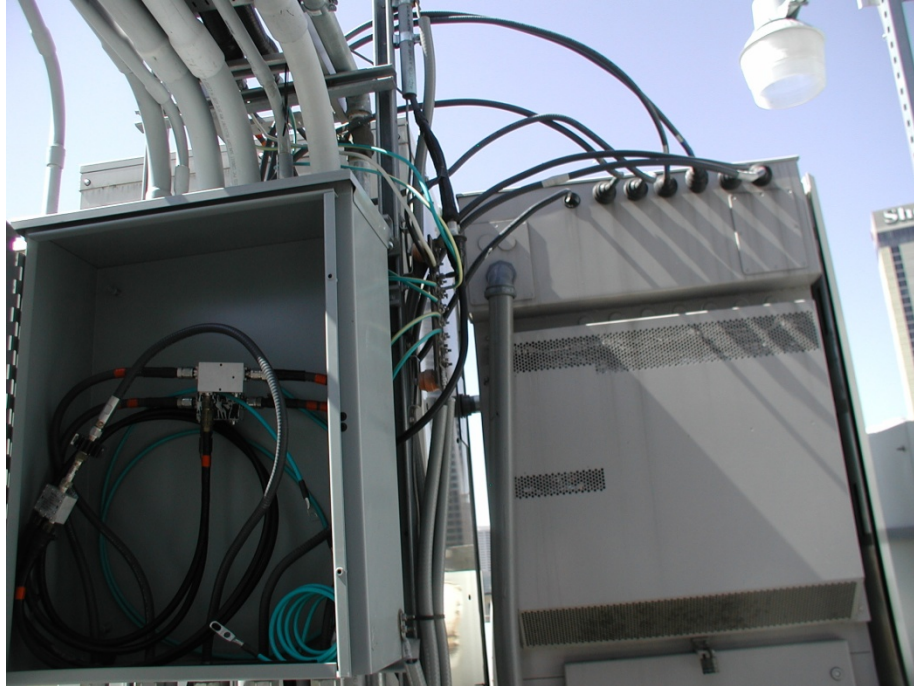
Figure 2 Rooftop cell and microwave sites have larger quantities of easily stolen copper wiring than do ground level sites, and increasingly these rooftops are being targeted by metals bandits.

While ground level cell and microwave sites experience significant thefts, rooftop sites are even more tempting to thieves because there is more copper available there. Many workmen have access to the roofs of the hotels, apartment houses and office buildings where cell and microwave sites are placed on roofs and increasingly these sites are being plundered.

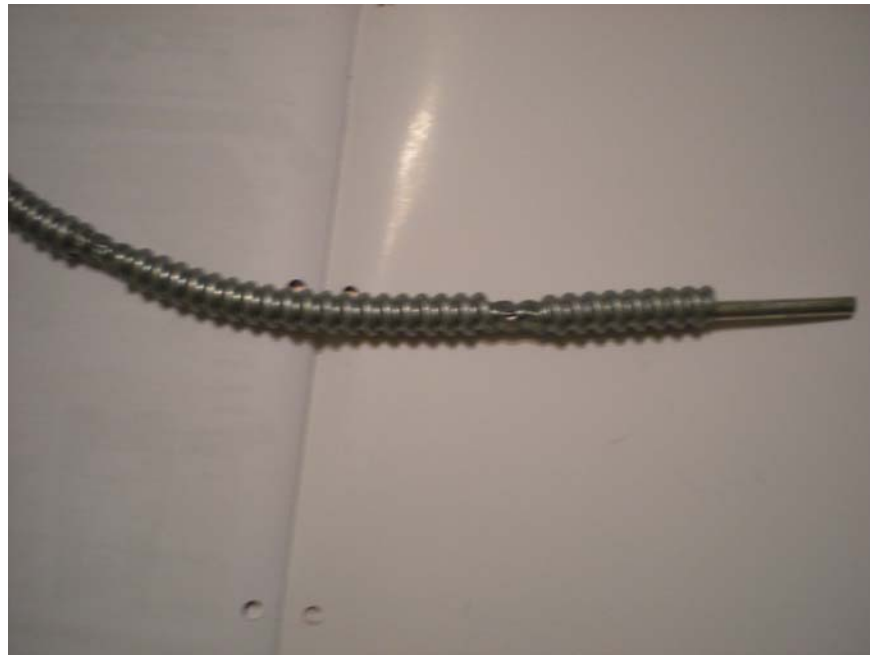
Figure 4 Crimped, armored #2 AWG BTCU wire.

Another approach is to make the copper difficult to separate from other materials such as insulation that might surround it. To that end a crimped armor was applied to #2 AWG solid bare tinned copper wire (Figure 4) and this too has improved copper retention. The crimps are on 8 inch centers and the thief would have to make so many cuts to get to the copper that the workload is a deterrent. This approach has been used for about two years now and has been effective at reducing copper theft. Another approach is making the copper too nasty to touch and one company has produced a sticky, tar-like substance that one paints onto assembled copper components. The material (Figure 5) is disgustingly pasty and difficult to remove from hands and clothing,

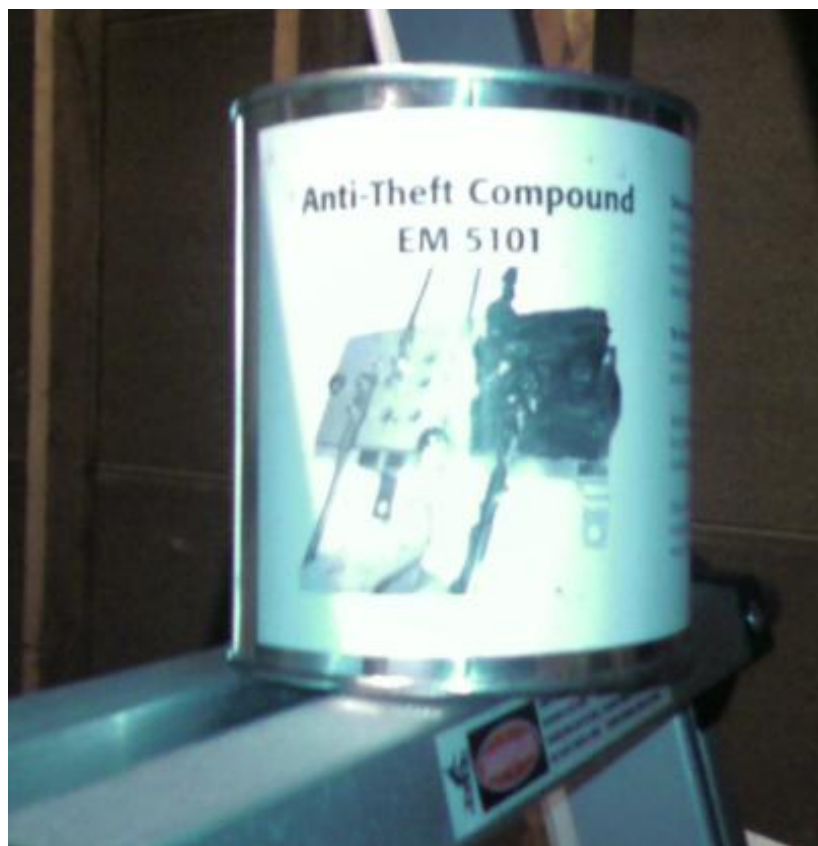
Figure 5 Theft deterrent compound

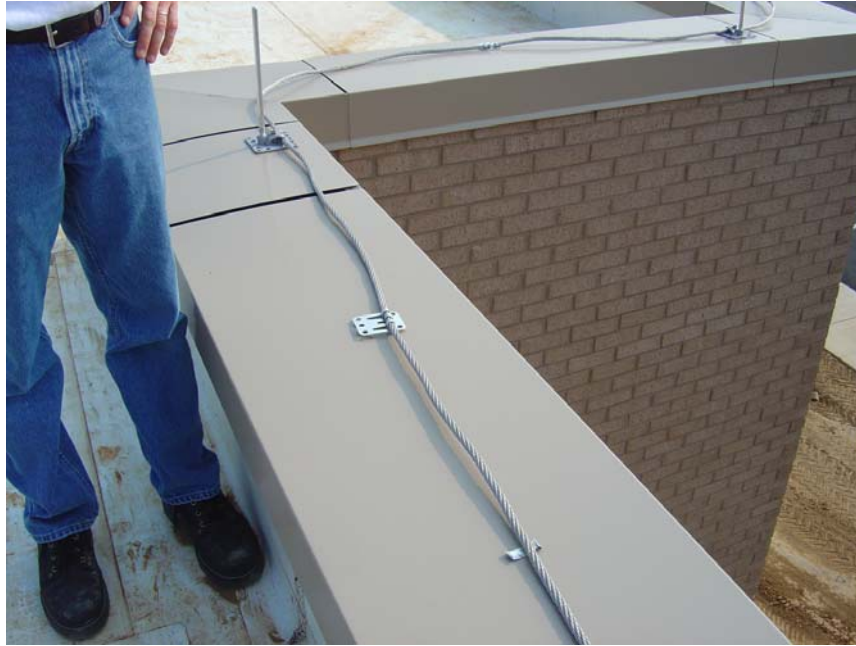
Figure 7 if aluminum wiring is adequate to provide lightning protection for a building, why then shouldn't aluminum conductors also suffice to bond and ground the systems and subsystems for a rooftop cell or microwave site? (Note: the system shown here is still being constructed; hence some of the connector bases aren't tightened yet, nor are the anchor plates cemented down with silicon sealer.)

Yet another approach is aluminum wire. As a practical matter, most of the US power grid is comprised of long haul high tension electrical transmission lines using aluminum conductors. Further, the lightning protection systems on buildings protected by lightning rods use either copper or aluminum depending on a number of factors, one of which is what other metals exist on the roof. Aluminum lightning protection system conductors are UL listed for the purpose and do a credible job. This situation begs the question: if aluminum conductors are perfectly adequate to protect a building from lightning, why then shouldn't aluminum conductors also suffice to bond and ground the systems and subsystems for a rooftop cell or microwave site?

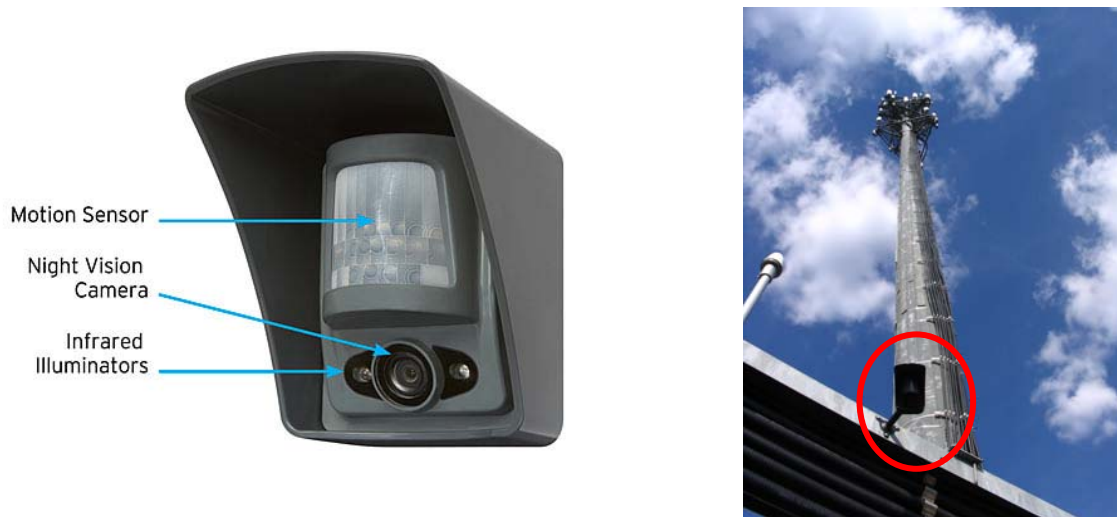
Figure 16 a motion detecting camera that reports events over the cellular network.

Another interesting approach has been offered by a company that combines a camera and IR light source with a motion sensor and a built in replaceable battery.

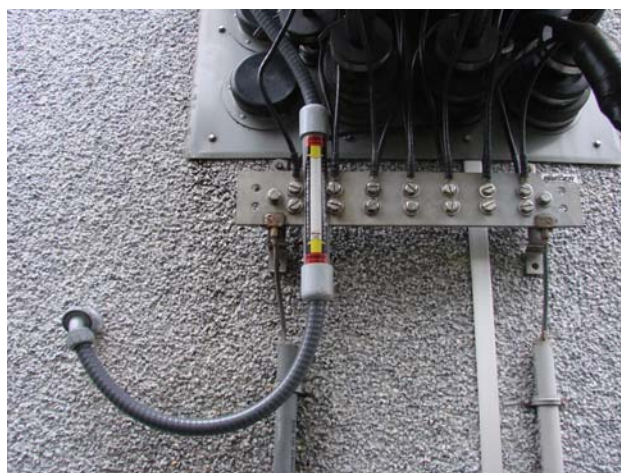
Figure 17, one method of alarming a ground bar.

Alarming the ground bar is an approach that some areas have tried with a fair level of success. Some simply loop a wire through a spare hole in the bar and then monitor the wire for continuity. Other designs are more complex. One shown in Figure 17 is essentially a plastic pipe that occupies a space on the unit. The bar can't be taken without compromising the wiring in the pipe and that wiring is conveyed into the shelter via a short length of Sealtite at the bottom of the unit. If taking any of the bar alarm approaches it's important to remember that lightning currents might enter the facility on the alarm leads and therefore it's prudent to use some sort of a primary protector on those leads to take overstress voltages safely to ground.
