The Changing Face of Power Cable

Dan McMenamain

Abstract

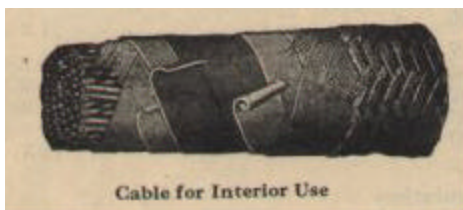
Figure 1 Vintage Cotton Braid Cable From Western Electric Telephone Apparatus and Supplies Catalog No. 6 January 1925

This cable literally built the business and cotton braid was used for both power and multiconductor cables often called "Switchboard cable." Some versions of the cable had a coat of fireproofing paint and others did not. Generally the rubber insulation was sulfur bearing and so the copper wiring needed protection from the corrosive effects of the sulfur. Usually tinning was the protection scheme of choice and on some of the switchboard cables the wire insulation was black enamel.

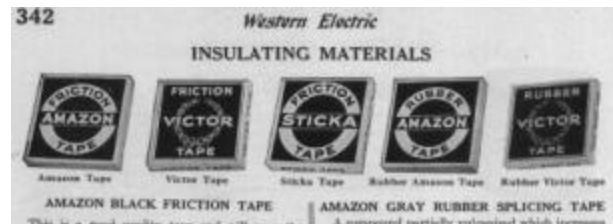
Figure 2 Rubber and Friction Insulating Tapes Circa 1925

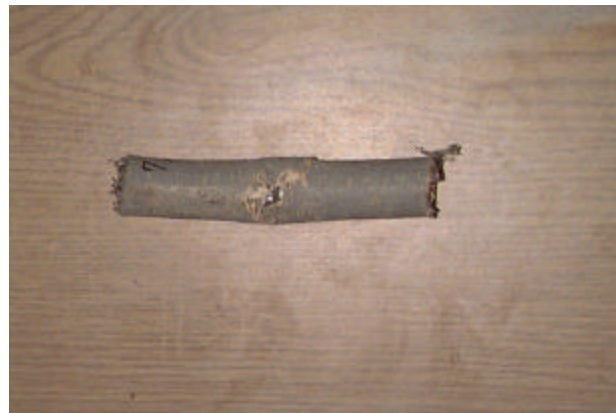
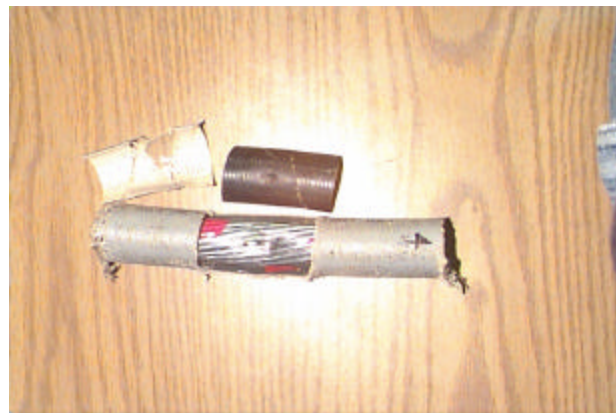
Textile-Covered RHW Cable With Strand Displacement Typical of B-Strand Failure Mechanism

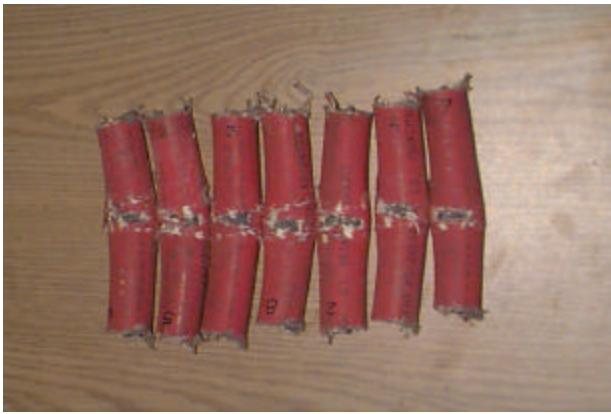
Textile-Covered RHW Following Tests

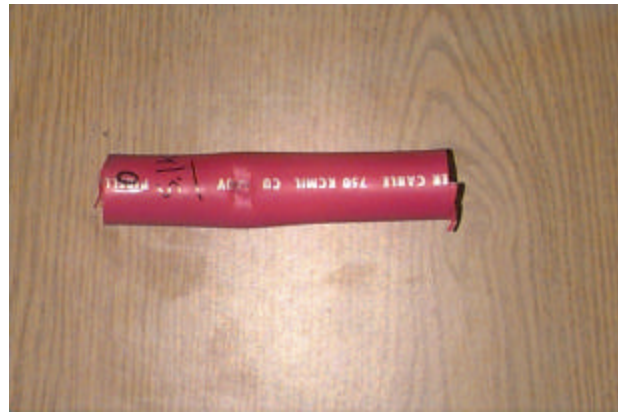
Plastic Insulated B-Strand Cable After Tests

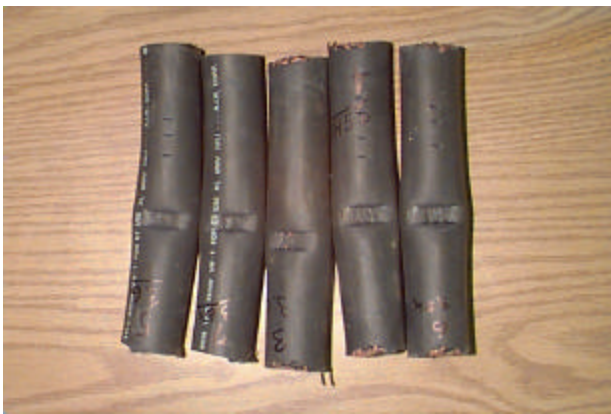
Plastic Insulated B-Strand Cable After Tests

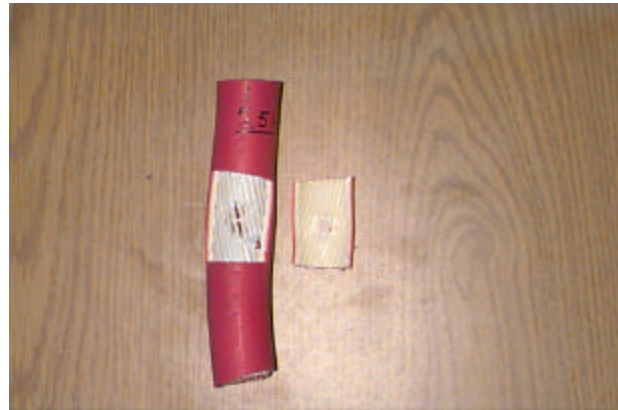
Cutaway of Plastic Insulated B-Strand Cable Showing Typical Strand Displacement

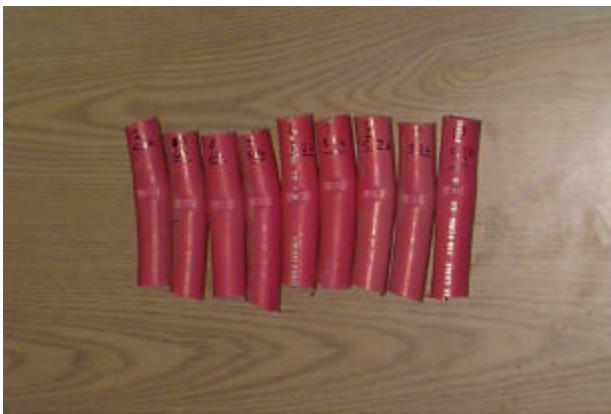
Plastic Insulated B-Strand Cable After Tests

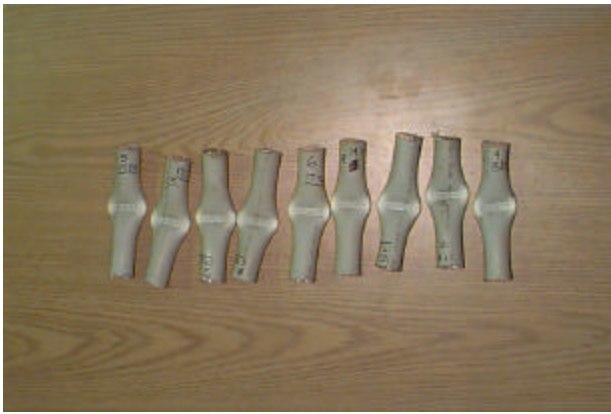
Point Penetration Test: Load Cell Signal Couples to Measurement Device to Indicate the Mechanical Load in Pounds Until Insulation Breach is Indicated by Electrical Continuity.

During our tests, we found that point penetration provided a more repeatable test than the cut-through simulation and so an arrowhead type fixture similar to the above was designed and fabricated. Like the others electrical continuity indicated a breach of the insulation and a load cell measured the weight in pounds.

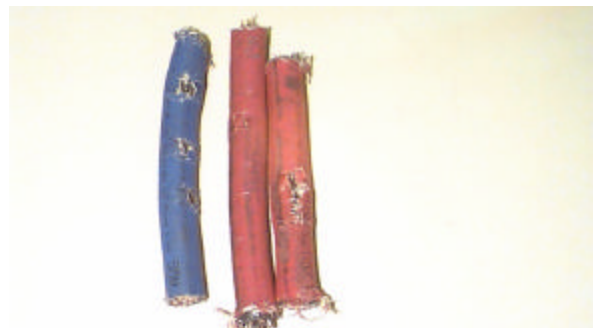
The second test was designed to test for cut-through resistance. A custom built fixture similar to the figure was designed to simulate the tightly concentrated pressure of a lacing cord. The test metric was the arbor force- measured in pounds - needed to breach the insulation and establish electrical continuity between the fixture and the conductors.

Compression Tests of New Generation Cloth Insulation 350 MCM Power Cable (left and right) and Point Penetration Tests (center).

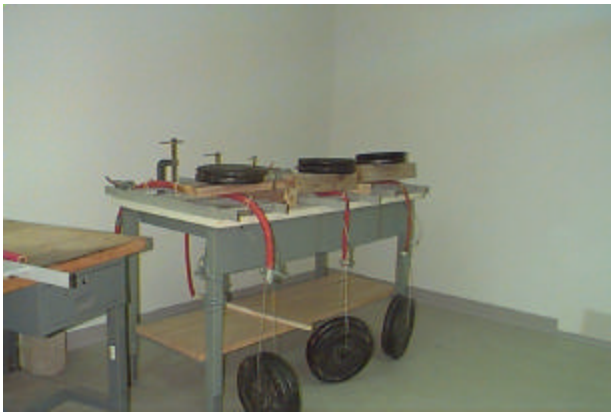
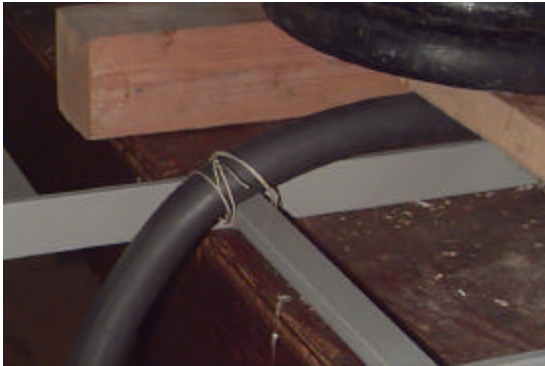
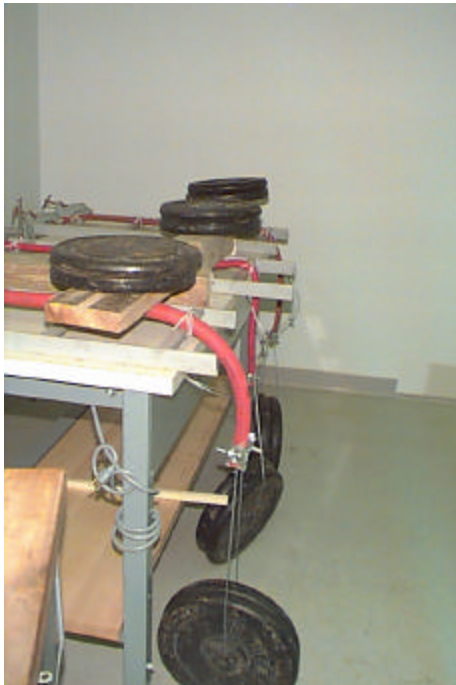
A final test was to secure lengths of cable to a cable rack, load the cable with 25 pounds per linear foot and suspend a 100 pound weight from one end of the cable for a stressed waterfall (see photos) simulation. This was allowed to age and then the insulation was examined for evidence of cold flow or other mechanical damage after 30 days of sustained heavy load.

The Sustained Load Tests Were Inconclusive Because No Damage Was Observed In Any Specimen After 30 Days.
