## Case Studies of Central Office Cable Tray Support Failures

Dan McMenamin  
Specialist - Energy & Environment

Bell Atlantic Corporation  
1717 Arch Street Suite 1700  
Philadelphia, Pennsylvania 19103 USA  
215-466-2125

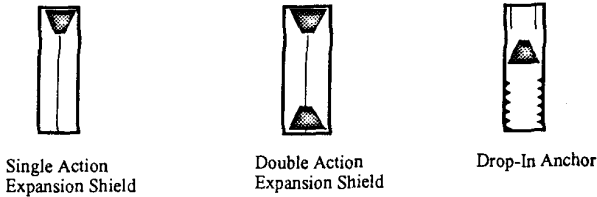
### Anchor Types Tested

At the request of Bell Atlantic, joint tests were conducted at the Bellcore research facility in Chester, New Jersey. Three types of anchor were tested: single and double action zinc-alloy expansion shields, Steel-alloy and Drop-In type anchors. Several units of each type were tested. One of the double action types tested was removed from the Wayne Central Office.

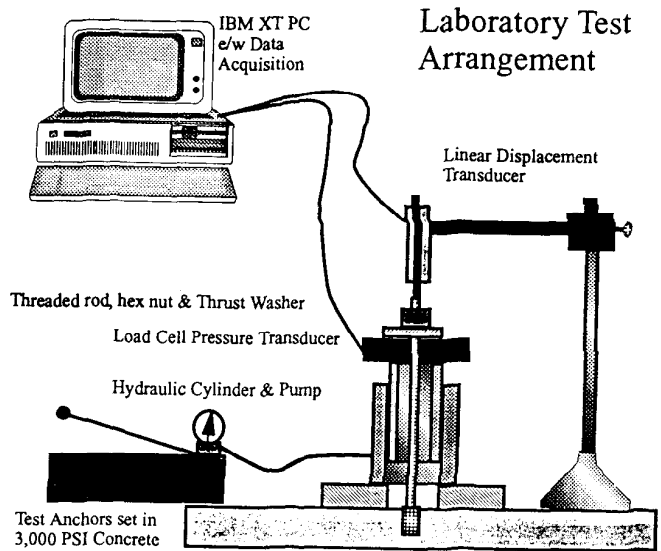
#### Lab Test Single Action Zinc Alloy

The single action expansion shields experienced 0.09 inches of creep at 2,500 pounds of load. At 7,150 the creep was 0.58 inches. As the test proceeded, the expansion cone traveled to 0.83 inches and caused stress fractures in the concrete slab. Cones of concrete some eight inches in diameter and 1.75 inches deep fractured out of the slab with the total failure of the anchors.
